# SuperTuff® Solution!

## Superior's 6F35/6T40 SuperTuff® Solution is Your Simple Solution™ for Ford and GM Case Bushing/Axle Seal Leakage

## SUPERIOR'S 6F35/6T40 SuperTuff® Solution

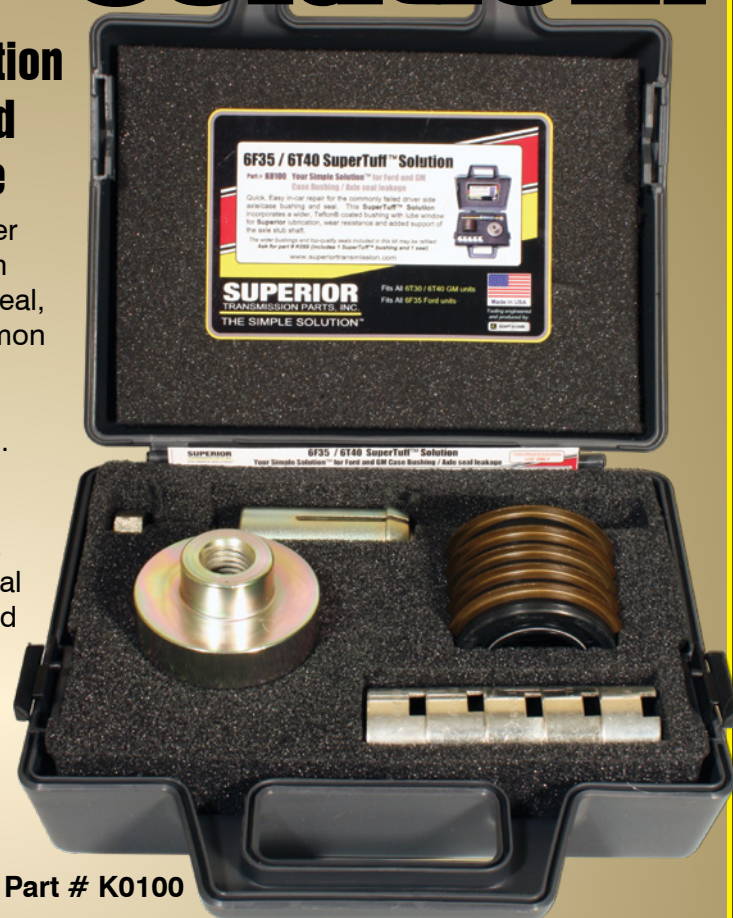
Part # K0100

The K0100 Kit includes: Our high-quality, 3-piece tool set designed for quick removal of the worn bushing and an indexed re-installation of the SuperTuff® bushing. The two-sided driver head also serves as the driver to install the included seal made of better-than-OEM materials. Kit also includes (5) axle seals and (5) original K099 SuperTuff® Teflon® bushings for a total of five (5) fixes. Refills for the K0100 are available: ask for Part # K099 (thin wall bushing; fits all 6F35 Ford units and 6T30/6T40 GM units up to 2014) or the NEW Part # K0199 (thick wall bushing; fits all 2014-up 6F35 Ford units and 2014-up 6T30/6T40 GM units). These can be used during overhaul as an upgraded seal & bushing fix.

Quick, easy, in-car repair for the commonly failed driver side axle/case bushing and seal. Failure due to a worn driver's side axle/case bushing can compromise the seal, causing shifting complaints or slippage which is common with a low fluid-level condition. This failure is caused by the original bushings inadequate surface area and lack of lubrication to bushing surface and CV axle cup. The durable SuperTuff® Teflon® coated bushing from Superior Transmission Parts Inc. virtually eliminates premature wear and the resulting leak at the axle seal. The new SuperTuff® bushing is 23% wider than original to offer more support, Teflon® coated for durability and engineered with a lube window that allows more oil in to provide better lubrication, wear resistance and added support of the axle stub shaft.

\*\*\*Address Premature Bushing/Seal Failures 6F35 Ford/Mazda and 6T40 GM units. The durable bushings and top-quality seals included in the K0100 Kit may be refilled: Part # K099 includes (1) SuperTuff™ bushing and (1) premium seal for the early version Thin Wall style up to 2014 OR use the New K0199 for 2014-up Thick Wall style. Note TOOL K0100 can use either Thin OR thick wall bushing to fit your application. One tool does both just order the K0199's as you need them.
